BOTH THE 1780 SURVEY OF ST. JOHN AND THE OXFORD MAP OF ST. JOHN'S PUBLISHED IN 1800 SHOW A BUILDING ON THE SITE OF THE EXISTING GREAT HOUSE. THE PRESENT BUILDING INCORPORATES SEVERAL LATE ADDITIONS FROM THIS CENTURY. THE DATE OF CONSTRUCTION OF THE OLDER MASONRY STRUCTURE HAS NOT BEEN DETERMINED. CORNICE & OTHER ARCHITECTURAL DETAILS IMPLY AN EARLY 19TH CENTURY DATE.

ESTATE MARY POINT

NAME OF STRUCTURE  
"GREAT HOUSE"  
SAINT JOHN

HISTORIC AMERICAN  
BUILDINGS SURVEY  
SHEET 1 OF 6 SHEETS

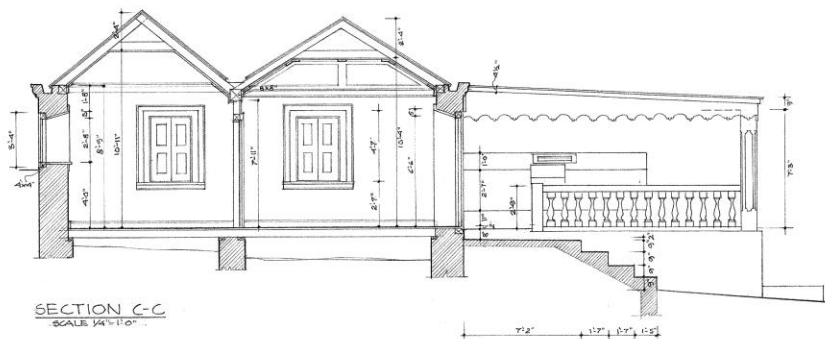
SECTION C-C  
SCALE 1/4" = 1'-0"

NOTE:  
INTERIOR MASONRY WALLS OF MAIN HOUSE ARE  
PARSED ONLY, THERE ARE REMNAITS OF NAILING  
STRIPS SET IN THE MASONRY AND THE WALLS WERE  
AT ONE TIME COVERED EITHER WITH CANVASS OR  
THIS BOARDING OF SOME KIND.  
THE REMAINS OF THE TRAY CEILING STILL IN PLACE  
ARE OF COMPOSITION BOARD WITH WOOD TRIM, TRACES  
ON BATTENS 4 TIES INDICATE THAT THE PRESENT ONE  
IS THE SECOND OR THIRD ON THE EXISTING NAILERS.
